DISPOSAL OF MINE WASTES BY BACKFILL OF EXISTING MINE EXCAVATIONS AT AN ABANDONED LEAD MINE IN MONTANA¹

Gary Lee Sturm, P.E.²

Abstract. The abandoned Cumberland Lead Mine Site near the historic ghost town of Castle was reclaimed by the Montana Mine Waste Cleanup Bureau in 2001. Reclamation of the site included the excavation and relocation of approximately 20,000 cubic yards of smelter slag and waste rock into an existing excavated pit. Prior to waste placement, a vertical shaft located in the pit was backfilled and the pit bottom was sealed with a 12 inch layer of native clay. Mine waste was placed into the pit repository in defined layers to better isolate the smelter slag within the backfilled waste. Another 5000 cubic yards of less contaminated mine waste were placed in a 100 foot long, 15 foot deep exploration trench. Both the pit and trench were capped with a multi-layer cap consisting of a geosynthetic liner overlain by a geocomposite drainage fabric covered by 18 inches of cover soil.

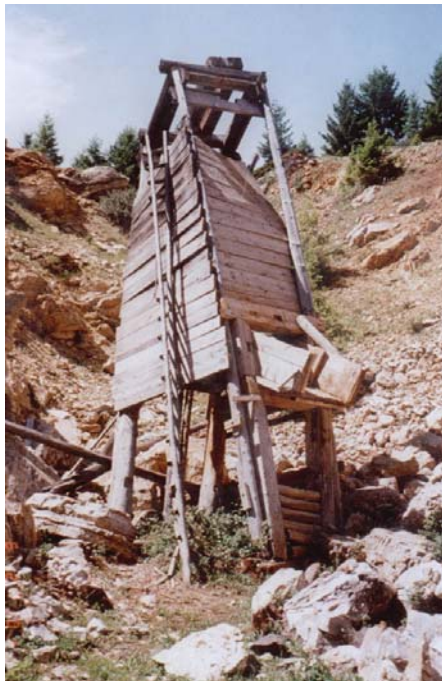
Several development shafts and extensive underground workings are present at the site. The discovery (upper) shaft is located on the Cumberland Lode on an outcrop of the vein and was reportedly sunk to a depth of 700 feet (Figure 2). The main (lower) shaft is located on the Stonewall Jackson Lode and was sunk to a depth of 500 feet. An adit is also located on the Stonewall Jackson Lode just upslope from the smelter slag dump. Groundwater was apparently encountered in both shafts. During mining groundwater had to be pumped to the surface for discharge.

Figure 2. Upper Shaft Headframe. August 2000.

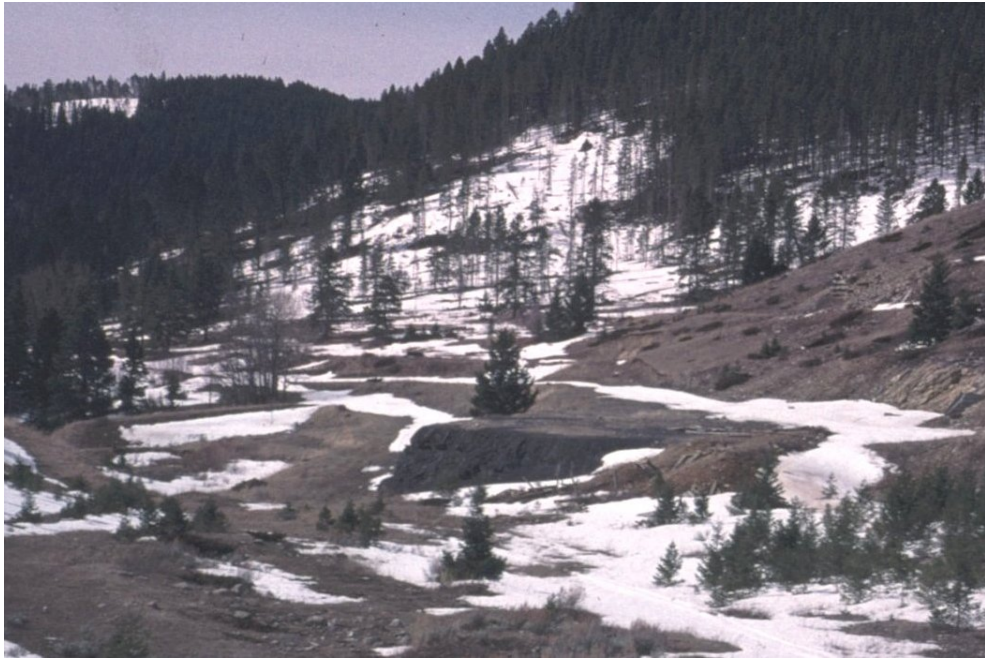
A large pile of smelter slag remained at the site after it was abandoned along with several waste rock dumps and abandoned ore piles (Figure 3). Several structures were

Figure 3. Smelter Slag Dump. April 2000.

Figure 8, a photograph of the smelter slag dump site taken this past summer , when compared to Figure 3, a photo of the smelter slag dump prior to reclamation; illustrates the successful reclamation of the site which once was the location of one of Montana's largest and most contaminated abandoned lead mines.

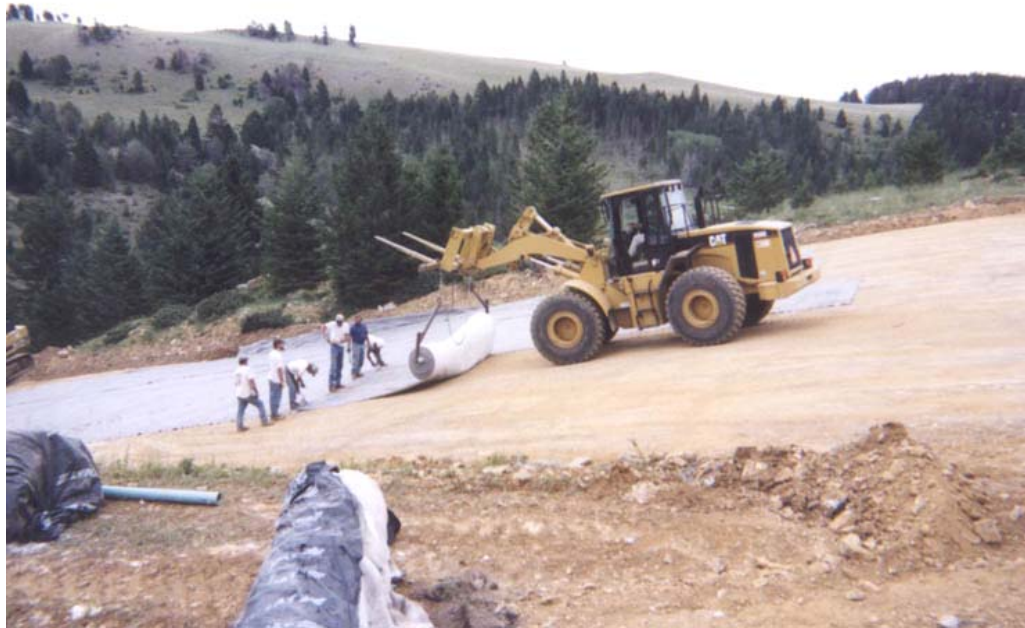
Figure 5. Laying Geosynthetic Clay Liner. September 2001.

Work at the site commenced on June 25, 2001 and all work except for seeding was completed by August 15, 2001. Seeding of the site was completed in early October 2001. Approximately 20,000 cubic yards of slag and mine waste were successfully relocated to the mine pit repository. An additional 2,750 cubic yards of waste rock were placed in the exploration trench repository. Approximately 5,880 square yards of multi-layer geomembrane/soil cap were placed (Figure 5).

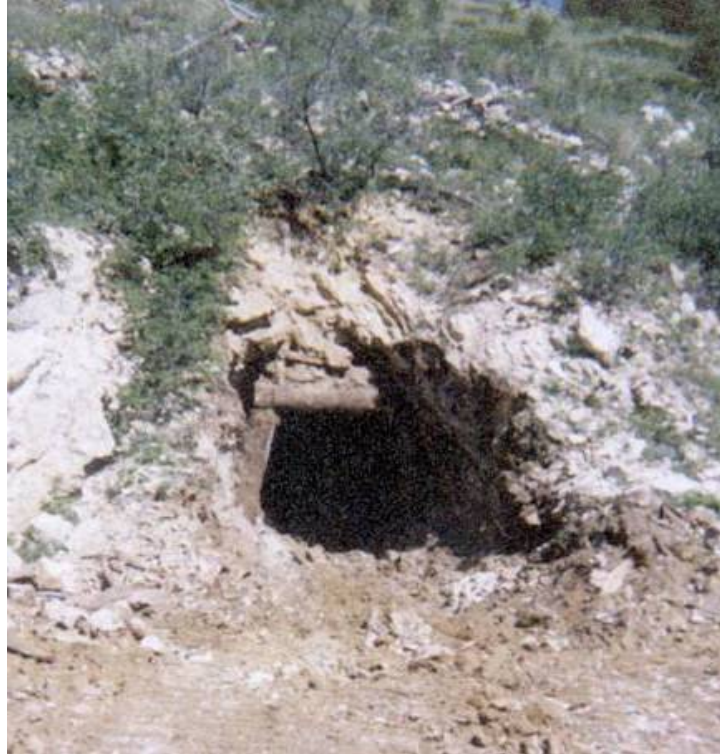
Figure 6. Open Adit Exposed During Reclamation. September 2001.

During construction several issues arose that required changes to the contract. The most important changes were the need to backfill the lower shaft and provide additional backfill at the smelter adit. While removing the metal debris from this shaft, it was discovered that the adit was still open to a depth of approximately 200 feet. Approximately 60 cubic yards of backfill were required to seal this adit. While removing wood debris from the smelter adit, the existing backfill was determined only to be a few feet thick. This material was removed (Figure 6) and approximately 20 cubic yards of backfill were pushed back into this adit providing a substantially more effective seal.

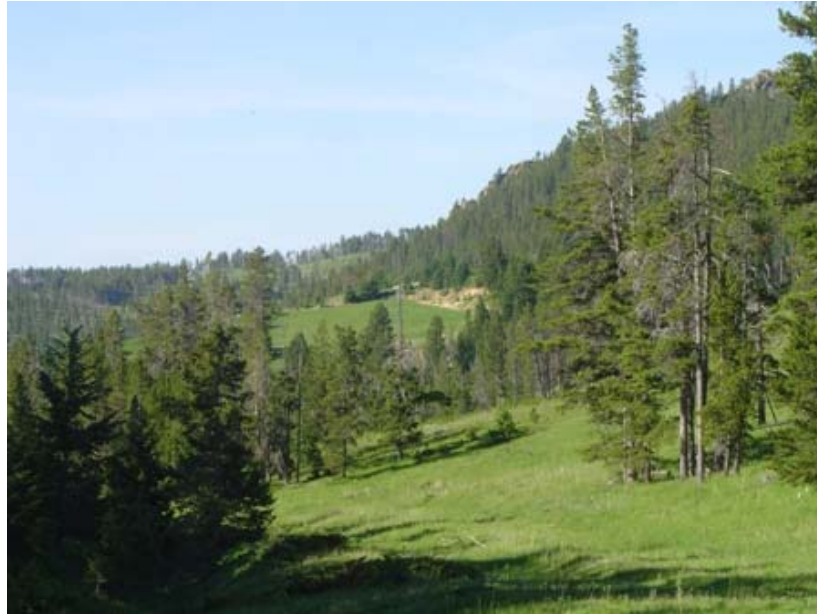
Site reclamation has been monitored by the state reclamation project manager and consulting design engineer on a yearly basis since completion of the work in 2001. While there are some areas of sparse vegetation within the reclaimed mine site due to the poor quality of the available cover soil, revegetation of the remainder of the site, especially the two repositories (Figure 7), has been exceptionally successful. Erosion of the reclaimed slopes is almost non existence.

Figure 7. Mine Pit Repository Cap Revegetation. June 2006.

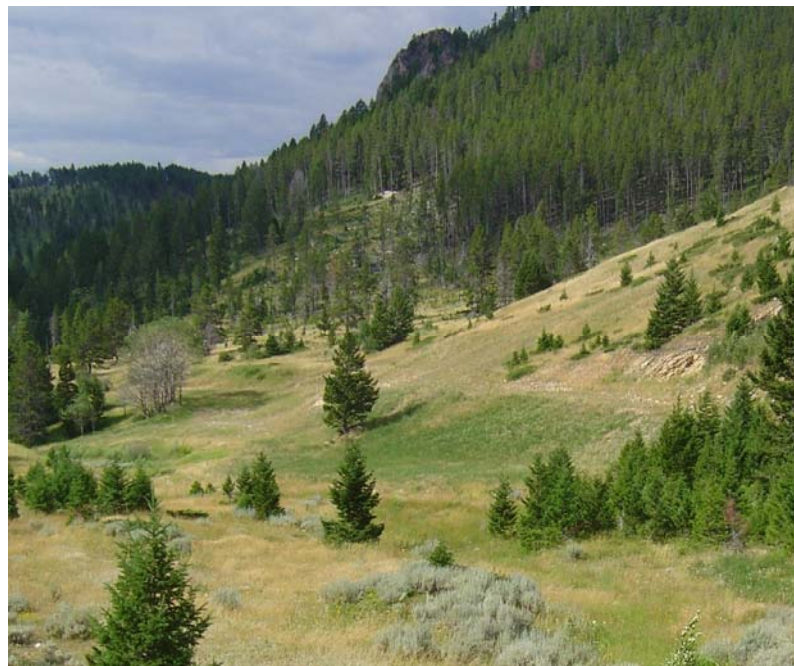
Figure 8. Reclaimed Slag Dump Site. August 2005.
